Allision of the Passenger Vessel *Seastreak Wall Street*  
with Pier 11, Lower Manhattan,  
New York, New York  
January 9, 2013

**Marine Accident Report**

NTSB/MAR-14/01  
PB2014-105712

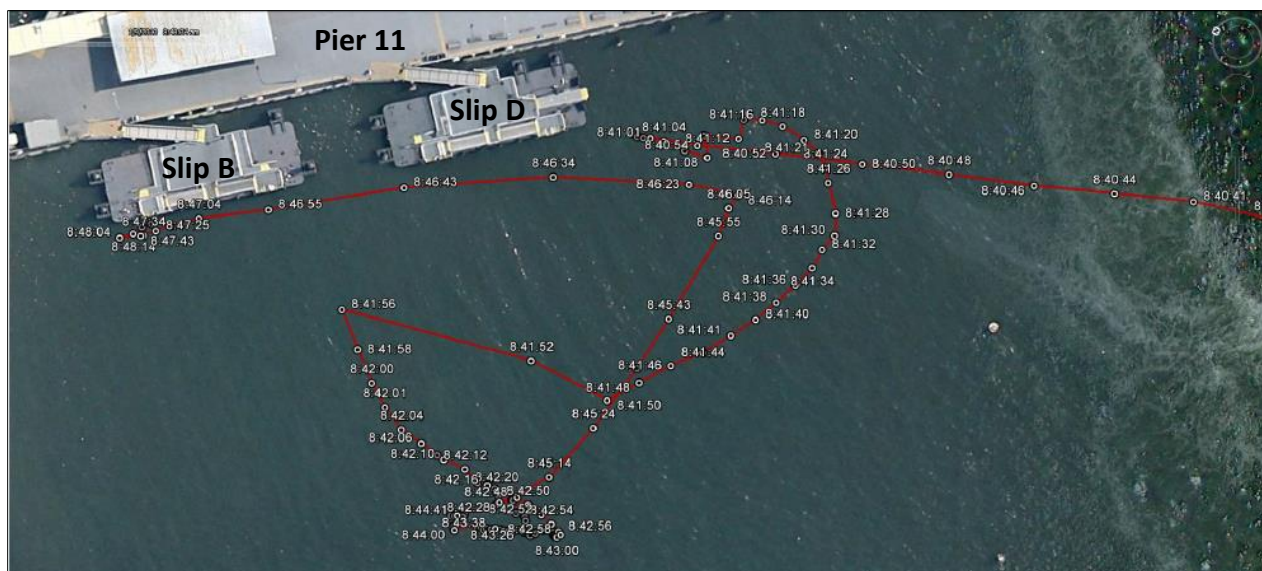
After impact, both main propulsion engines continued running for about 68 seconds, consistent with the time the vessel ran aground in shallow water near the pier. The captain said he instructed a crewmember to restart both engines and then maneuvered the vessel to Slip B at Pier 11 about 7 minutes later. Figure 2 depicts the *Seastreak Wall Street*'s route from New Jersey to Manhattan. Figure 3 plots the last 7 minutes of the ferry's voyage.

**Figure 3.** Automatic information system (AIS) data showing the ferry's trackline for the last 7 minutes of the accident voyage, including impact with the pier, grounding in shallow water nearby, and finally docking at another pier. Times are shown at locations where this information is available. (Background by Google Earth)

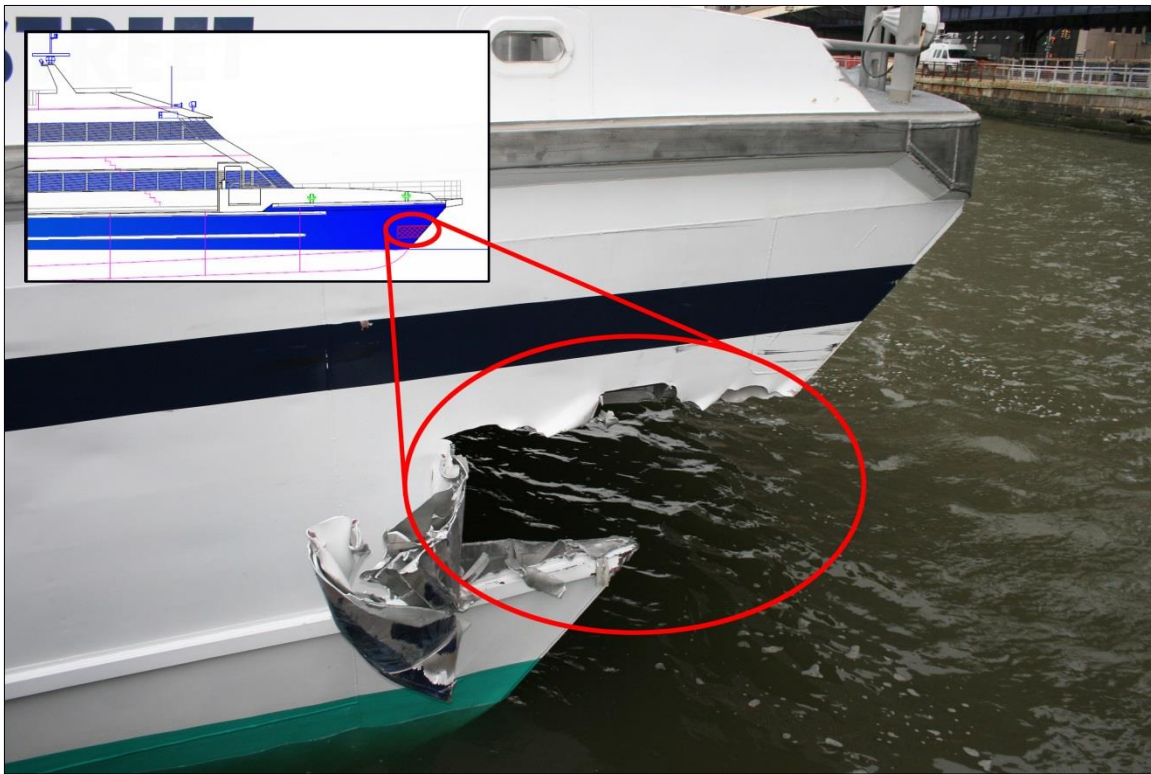
One interior window at the bottom of a stairwell was broken, broken glass was found in the main deck forward stairwell and at the second deck starboard aft door, and a passenger seat back rest on the main deck was broken. Damage to the vessel hull was principally to the starboard bow and to the cross-member connecting the two hulls. Impact to the starboard hull at the point where it struck the pier resulted in a 30-inch opening beginning about 30 inches above the waterline and extending 45 inches at the lower side and 76 inches at the upper side. In this area, the side shell was crushed and peeled away from the hull, and internal frames were displaced (see figure 5).

**Figure 5.** Damage to the *Seastreak Wall Street* starboard bow.

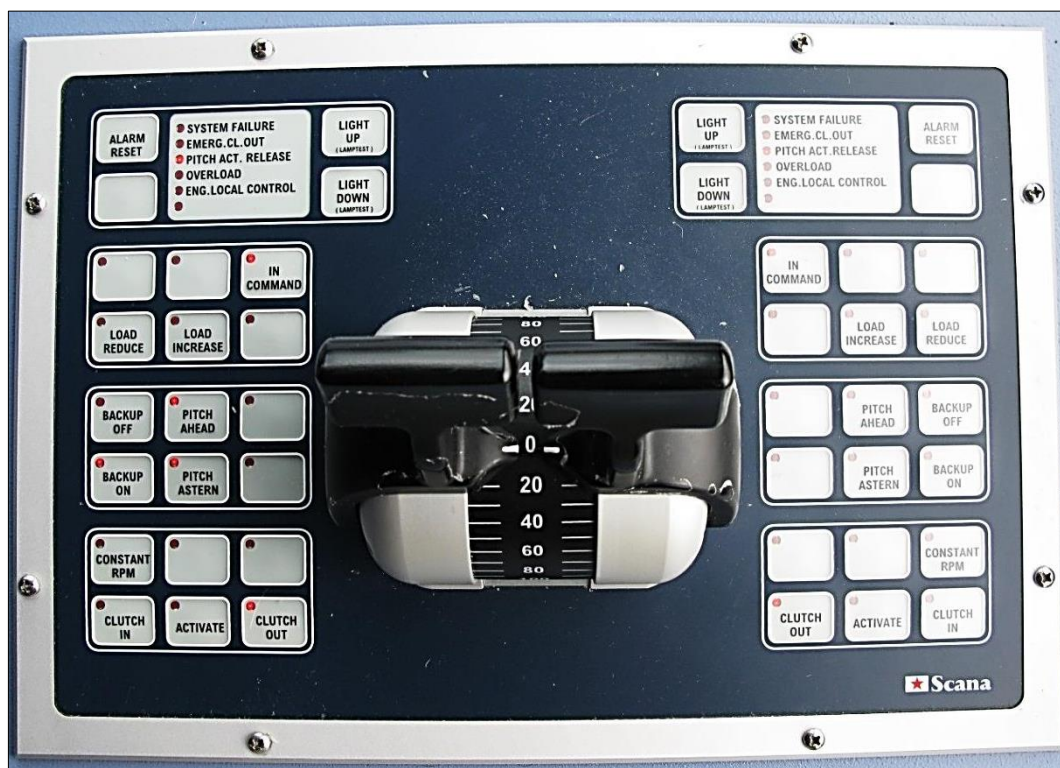
**Figure 13.** Closeup of bridge control panel order levers and command buttons.

In Backup mode, order levers controlled only engine rpm at the station in command, and ahead and astern pitch were controlled by pushbuttons at any control station. If the propulsion system were in Backup mode, rather than Combinator mode, while approaching the pier and the captain moved the order levers astern, the propellers would still be in the forward pitch position. Thus, any increase in rpm—even if commanded by moving order levers astern—would cause the vessel to increase forward speed rather than slow down. This scenario is consistent with AIS speed data, which showed an increase of nearly 2 knots in the seconds prior to the allision.

Audible alerts and alarms also could be improved. As currently designed, engaging Backup mode triggers a constant audible alert that could only be reset by the operator. After the reset silenced the alert, no further alarm would sound to remind the operator that Backup mode was still active. If the operator approached a dock without realizing the propulsion system was in Backup mode, the vessel would not respond as expected, thus posing a safety hazard.

In addition, the NTSB recommends that Scana Mar-El AS modify its design for new Neptune Compact propulsion control systems to include clearly identifiable audible alerts and easily visible and understandable displays that will remind the operator when Backup mode is engaged and revise its owner's manual accordingly. The NTSB also recommends that Scana Mar-El AS design a solution for existing Neptune Compact propulsion control systems to include clearly identifiable audible alerts and easily visible and understandable displays to indicate to operators when Backup mode is engaged, revise its owner's manual accordingly, and alert its customers to the circumstances of this accident and to the availability of the retrofit solution.

The NTSB further recommends that Seastreak LLC work with Scana Mar-El AS to implement a modification to the Neptune Compact propulsion control system that includes clearly identifiable audible alerts and easily visible and understandable displays to remind the operator when Backup mode is engaged.

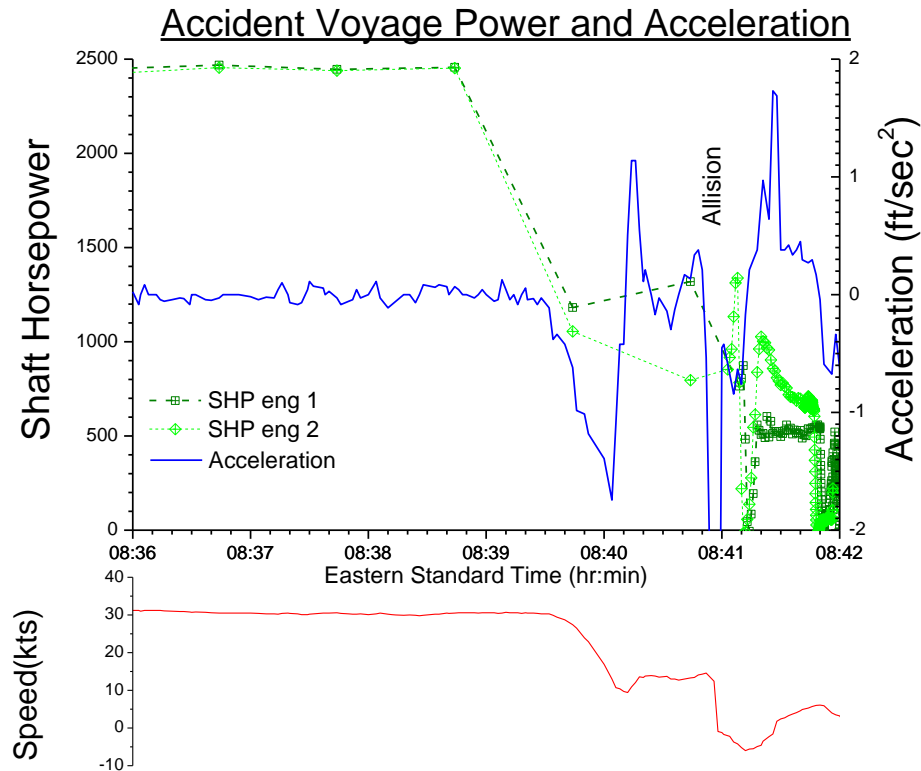
Engine data were recorded once per minute before the allision. Acceleration is plotted with shaft horsepower in figure C-3 to indicate the power change trends required for the recorded speed. The acceleration curve indicates that the power reduction occurred about 0839:30, approximately 40 seconds after the last recorded 2500-horsepower engine data point. The acceleration curve also shows that forward power was increased about a minute before the allision. This would require an increase in rpm and, thus, rpm control.

**Figure C-3.** Power, speed, and acceleration.

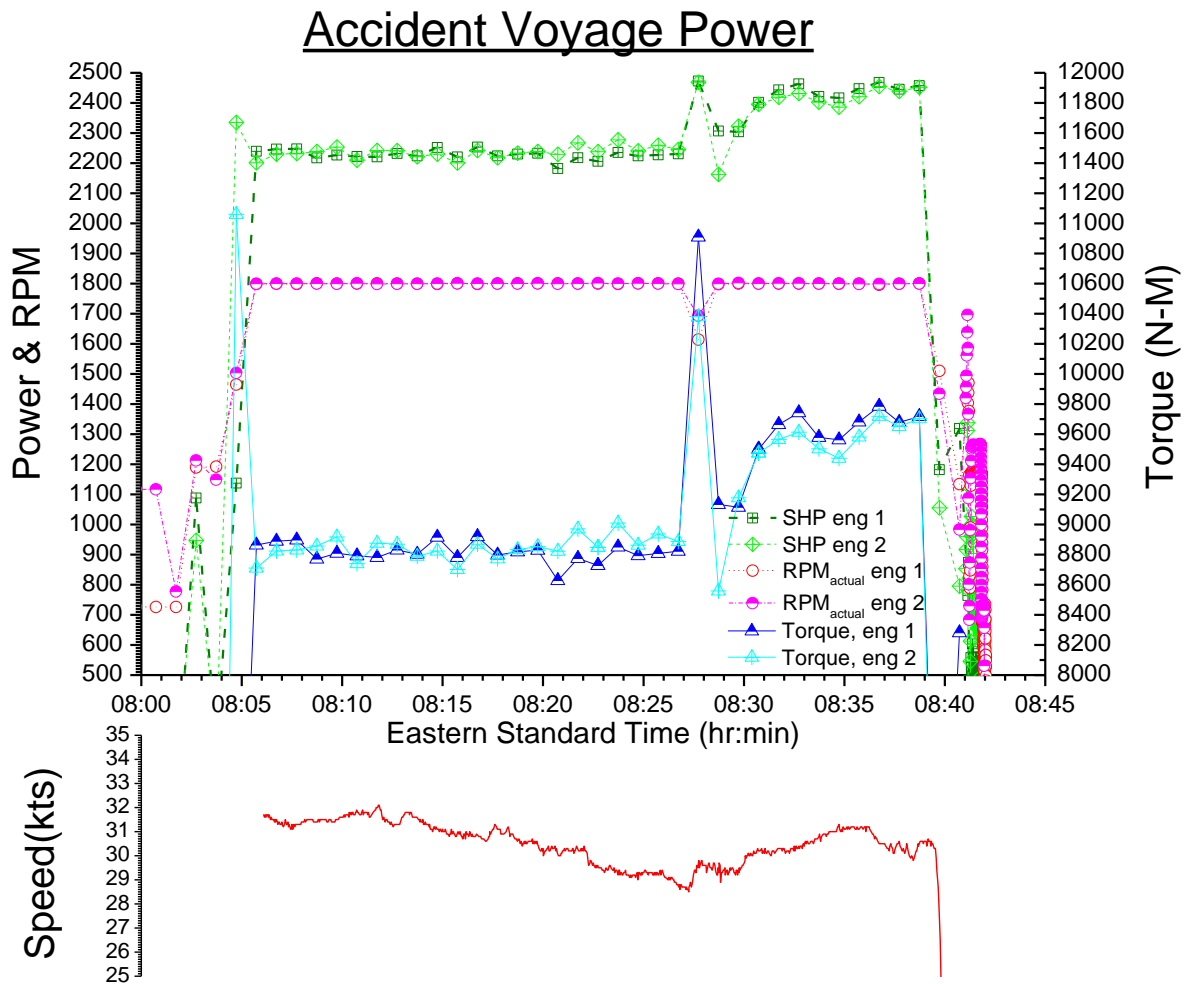
The data were also examined to check whether the power parameter relationships earlier in the voyage could provide insight into the propulsion control mode (Combinator or Backup). Calculated power, recorded rpm, torque, and speed are plotted in figure C-4 for the accident voyage. Note that AIS speed data were not available before about 0805. The engine traces indicate acceleration to cruise beginning about 2 minutes earlier and accompanied by a power spike to about 2335 shaft horsepower.

**Figure C-4.** Engine rpm, power, torque, and speed for the accident voyage.

In Combinator mode, the order levers controlled engine rpm and propeller pitch, and thus power. Until about 0820, a fixed relationship existed between the three parameters. About 0820, the port and starboard torque and power separated while engine rpm remained constant at 1800 rpm. The steady rpm indicates that the command lever position must have been constant through this period. At 0827, torque and power increased while rpm decreased. This was not possible in Combinator mode, indicating that the vessel was in Backup mode by this time. After 0827, the engines returned to 1800 rpm while torque decreased briefly below the earlier cruise value before increasing to a value significantly above the earlier cruise value at 0831. These torque changes
